Report on a short assessment of the shore vegetation of Five Blues Lake National Park.

May 26, 2001

Report to PACT

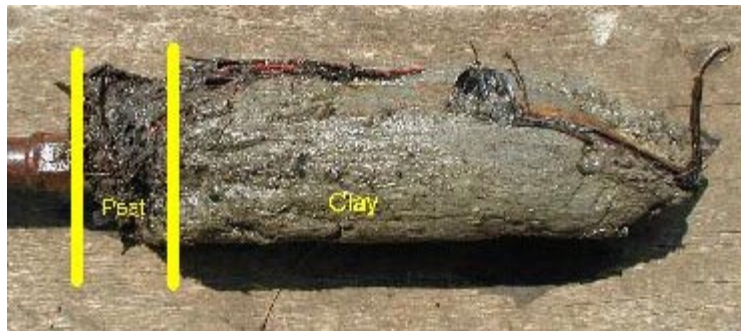
The soil cores taken in the reed beds revealed a thin layer of peat on top of a thick layer of sticky clay. The peat layer varied in thickness from 8" (20 cm) in shore locations (slightly above current water level) to 1" (2.5 cm) in the actual submerged reed beds. No traces of recent soil deposits (as from recent deposits of eroded material) could be detected in the layering of the core samples.

Picture 2. 20 cm soil core with peat and clay layers indicated

The thickness of the peat layer appears to indicate that the presence of this plant along the shores of the lake is not of recent origin. The relatively thin peat layer in the deeper sections might be indicative of a relatively recent colonization of these parts. This observation corroborates with the observations made by Mr. Peraza.

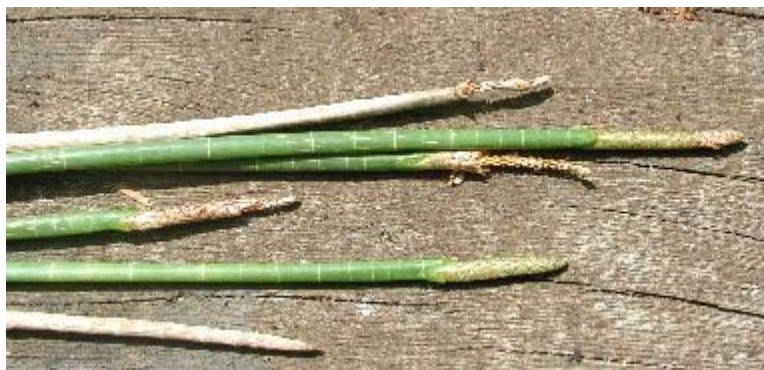
The “reed” is actually a sedge (Cyperaceae) of the genus *Eleocharis*. Using Standley and Steyermark 1946-1978, the species keyed out as *E. intersticta*. This is a wide ranging species with a distribution from Southern USA, the Caribbean through to South America.

Picture 3. *Eleocharis intersticta*. Note terete, septate culm (= rounded stem divided in sections) and flowering spike
